Optikos Case Study

Optical Forensic Analysis

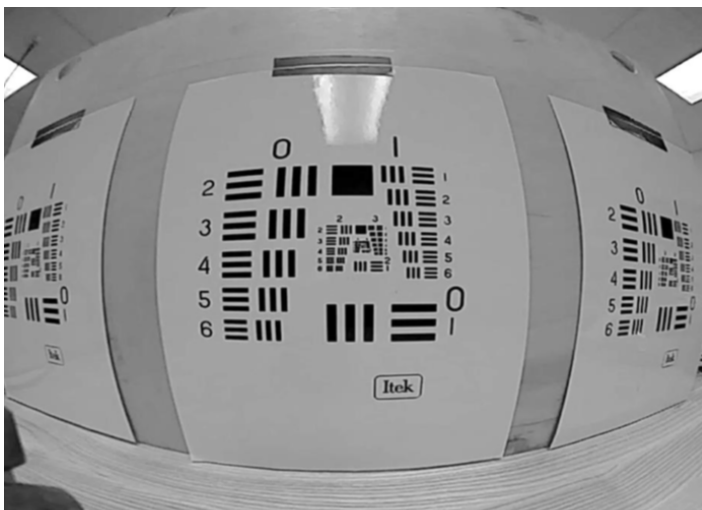
Three U.S. Air Force 1951 resolution charts were mounted on a flat board at a specified distance from the lens assembly. Acceptable and unacceptable reference images were taken using "Good Assemblies", Figure 1, and "Bad Assemblies", Figure 2, respectively.

Figure 1 - Acceptable Image

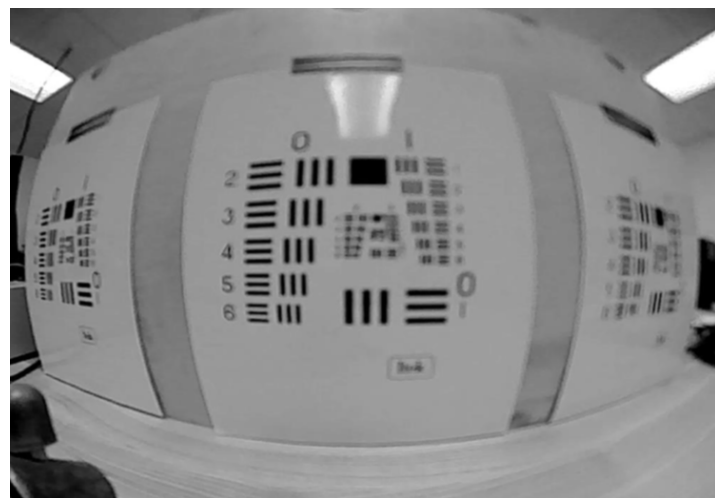
Figure 2 - Unacceptable Image

IQ Lab Services discovered that axial displacement of one of the lens elements was the primary factor in image quality degradation. The optomechanical design housing this element did not provide sufficient constraint, leading to failures in outgoing inspections.
